PRESERVATION ASSESSMENT OF CITY CEMETERY, SOUTH BEND, INDIANA

Chicora Research Contribution 512

Prepared By:
Michael Trinkley, Ph.D.
and
Debi Hacker

May 1, 2009

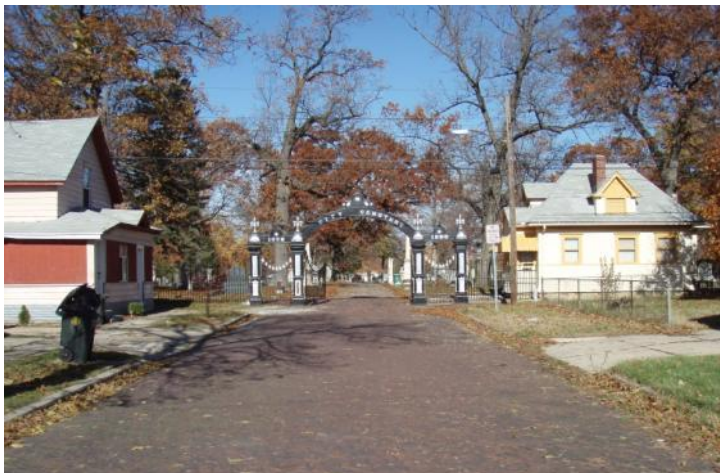
Figure 13. Entrance to the cemetery. This could be greatly improved by removing the existing structures and replacing them with period appropriate landscaping. The brick pavement should be carefully retained.

Private residences border this approach and while they are generally well tended to, they lack architectural merit and detract from the statement that the entrance could make. We recommend that the city gradually obtain these properties as they become available, the structures be demolished, and the approach planted in heirloom plantings typical of the Victorian period (we select this period since it would have been about this time when the gate was erected and the cemetery layout modified).

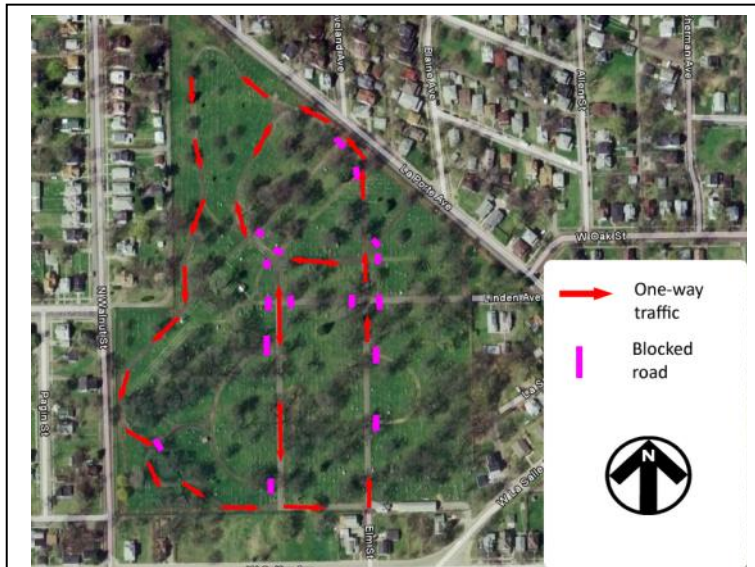
Figure 15. One possible example of how the roads in City Cemetery could be modified to improve traffic flow if visitation increases.

roads to vehicular traffic using lockable bollards and posting the remaining roads as one-way. One possible design is shown in Figure 15. This would serve to simplify a driver's choices and encourage greater pedestrian use of the facility. The bollards, however, could be removed for service vehicles as necessary.

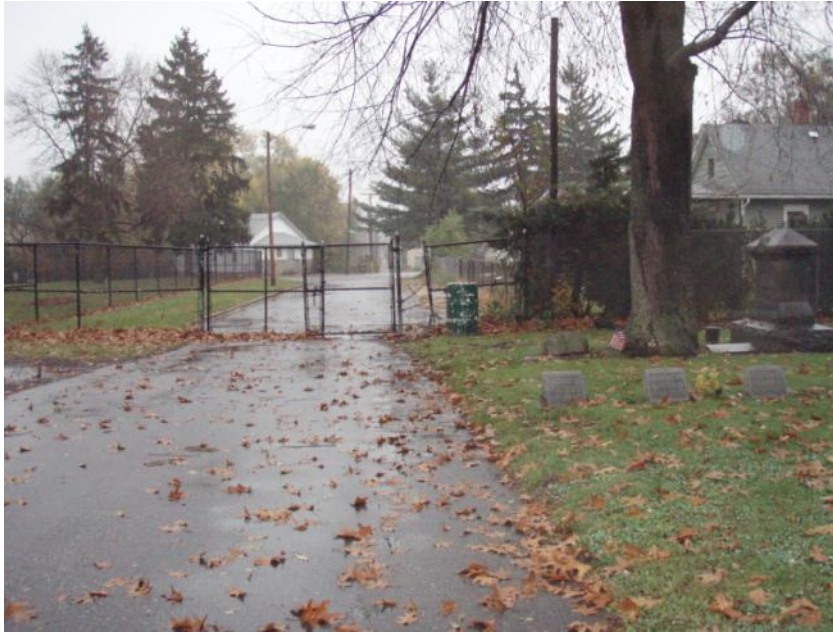
Figure 16. Improperly set gate on the east side of the cemetery at Linden Avenue. This requires immediate attention to eliminate the pedestrian passageway.

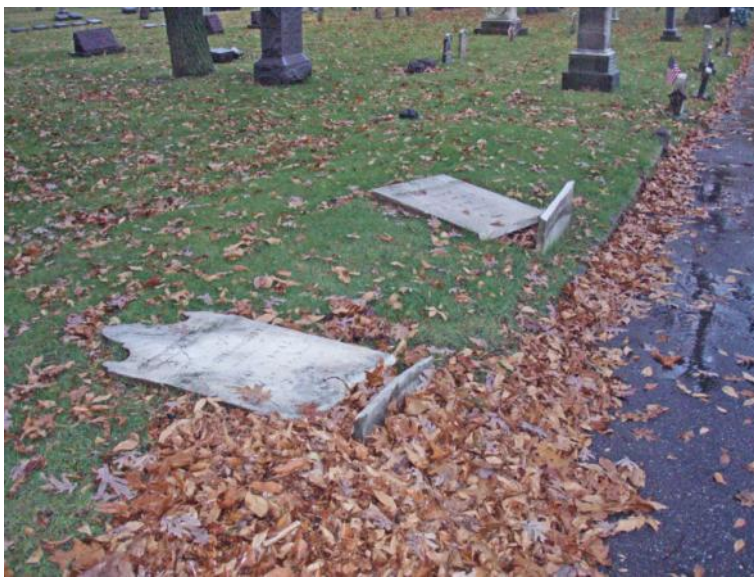
Figure 17. Recently vandalized monuments immediately adjacent to one of the cemetery's main roads.

It is also essential that vandalized stones be repaired. Simply allowing broken stones to

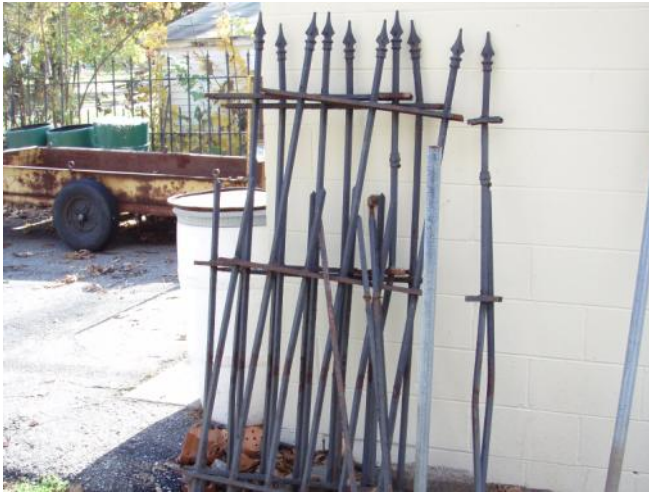
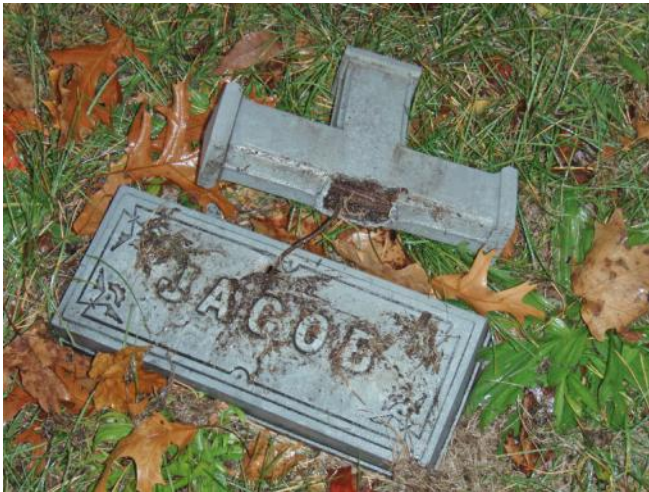
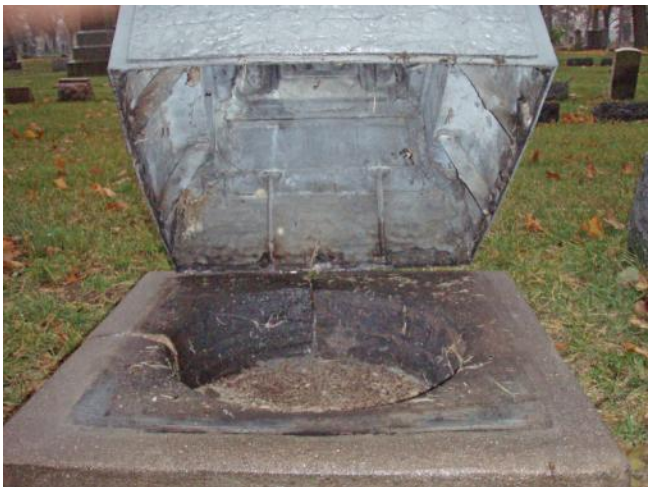
Figure 18. Examples of unattached ironwork or zinc monuments that could be easily stolen.

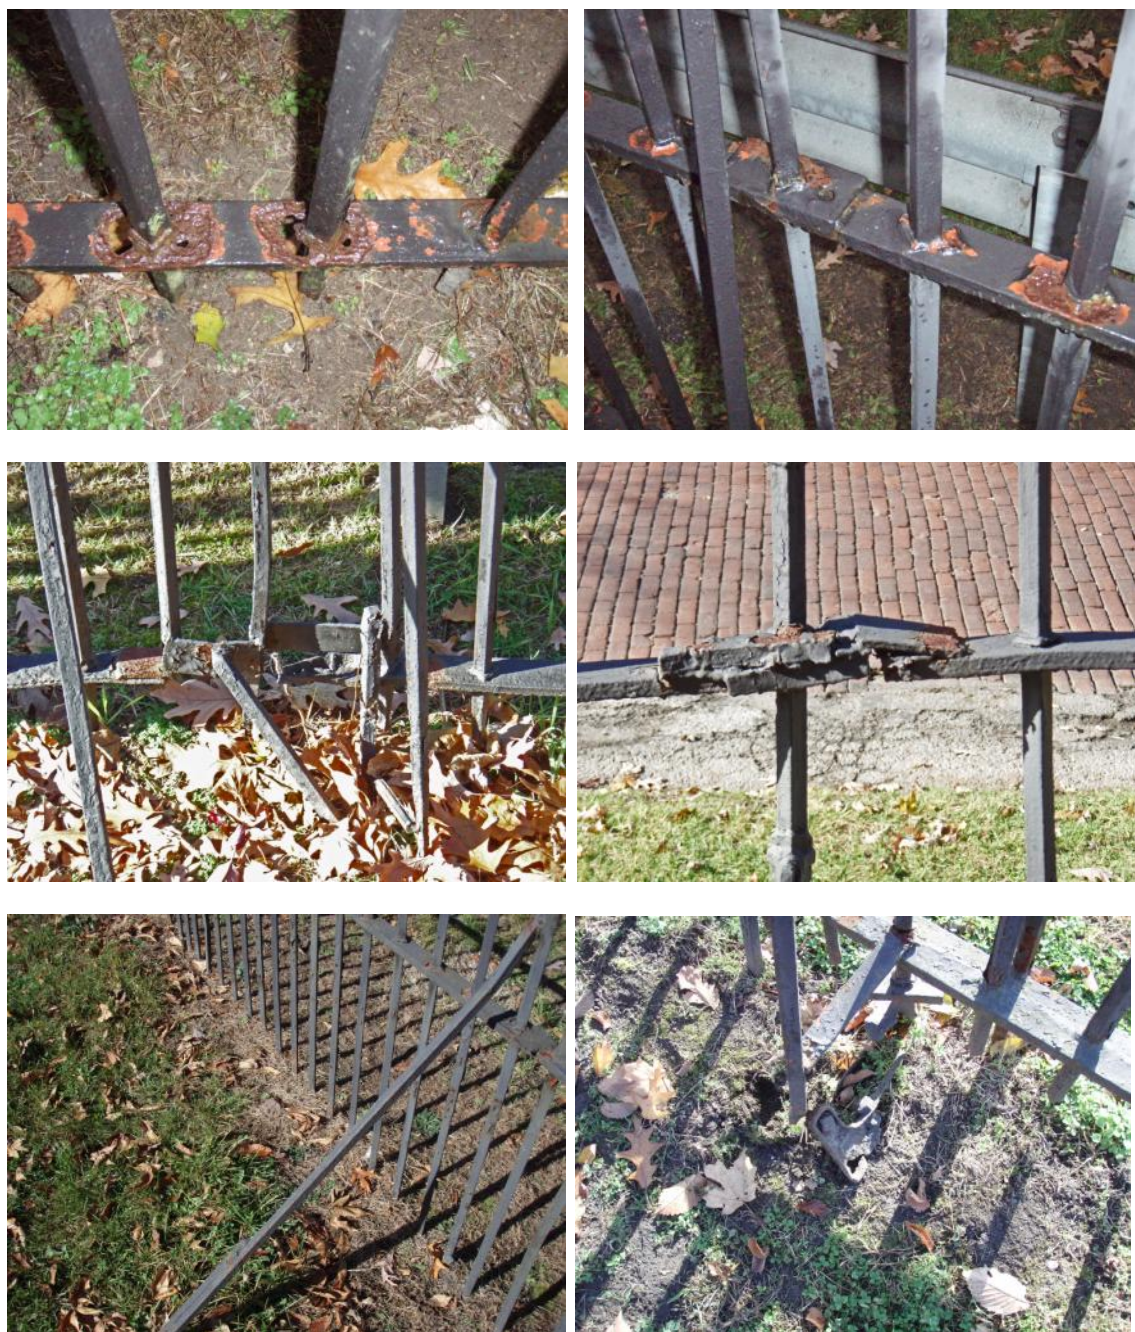
- Welding throughout is of the poorest workmanship and is entirely inappropriate for historic fabric. All

Figure 20. Problems with the City Cemetery boundary fence. Upper left shows an example of extensive corrosion and failing paint. Upper right is an example of failing paint. The middle row shows two examples of the very poor workmanship used in fence repairs. This quality of work must not be allowed on historic fabric and all such repairs must be removed. Lower left shows the bottom rail buried in soil. The lower right shows a loose part lying on the ground and a line support completely corroded through.

There is much infrastructure or hardscape that requires attention. Top on this list is the historic boundary fence. This fence has received very poor care over its history, consisting of entirely unacceptable welding repairs and inadequate painting. At this stage it is critical that all old welds be removed and a competent craftsman make the required repairs. After that is accomplished the fence should be cleaned to near white metal, primed, and repainted.

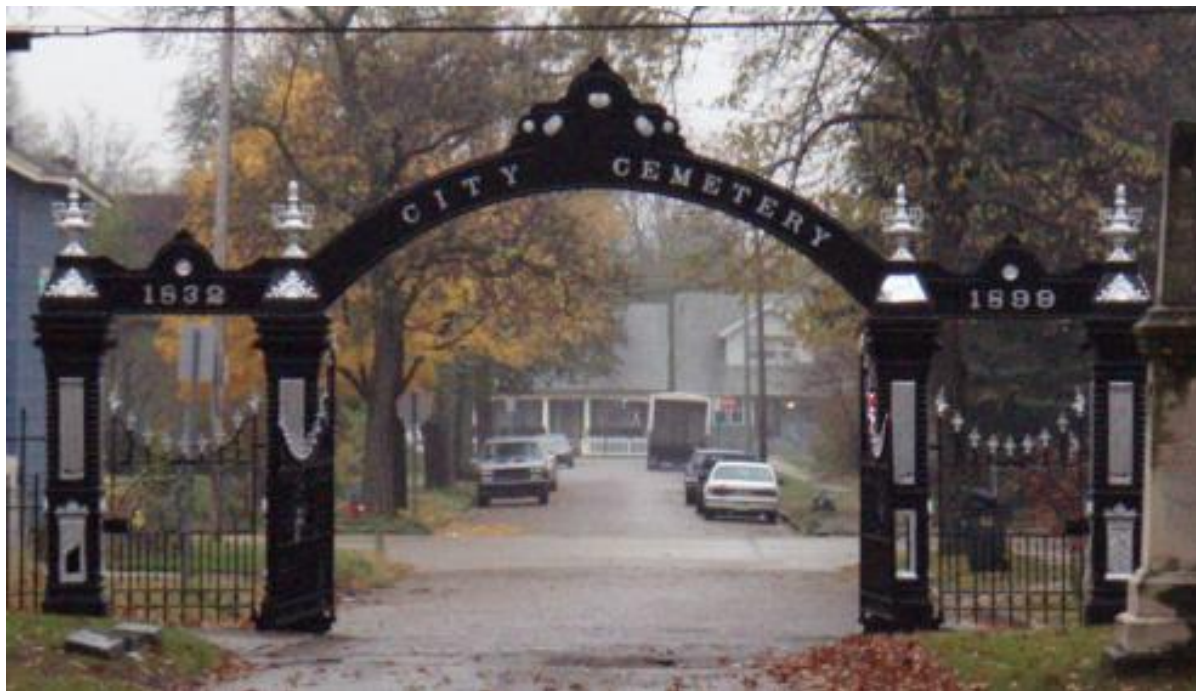
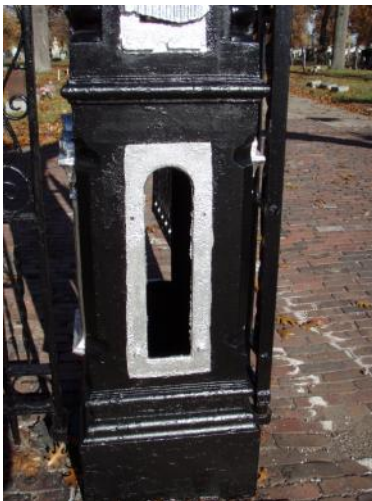
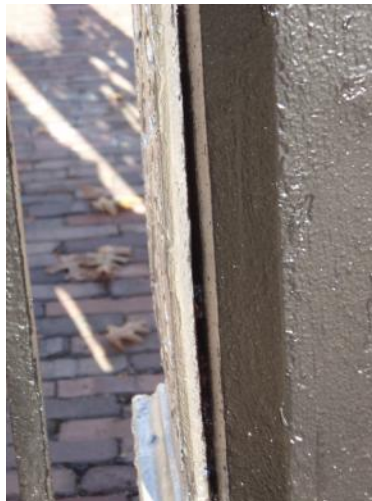
Figure 21. Gate problems. The top photo shows the entrance gate from within the cemetery looking toward Colfax Avenue. Below from left to right, an example of missing fabric (above is part of a cover plate that has been broken), a joint in the post that requires careful caulking prior to painting, and damaged decorative design and old weld that has broken apart (repair will require disassembly of the column, although water can be repelled by careful caulking until the repair can be afforded).

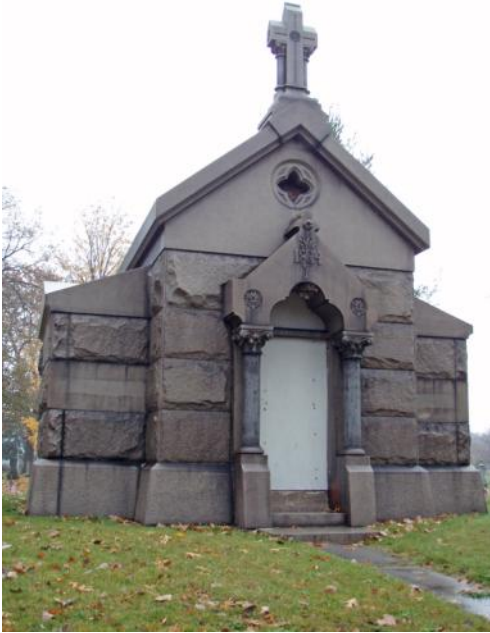
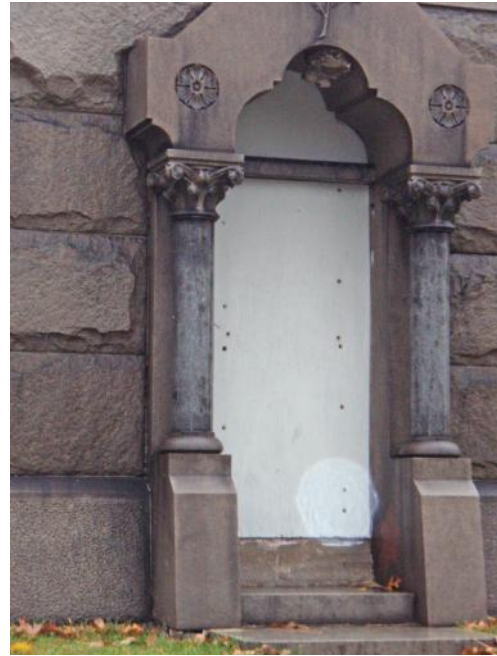
Figure 22. The Miller Mausoleum should receive a more detailed assessment, but initial observations indicate that the structure requires repointing and cleaning of atmospheric pollutants. The wooden door should also be removed and, if necessary, replaced with a fitted iron grill.

The assessment of the two mausoleums in the cemetery will cost \$3,400. These are massive structures – midway between a house and a monument. They face the same sorts of problems we typically associate with structures – leaking roofs and foundation collapse. Thus, their assessment is another critical element in the budgeting process.

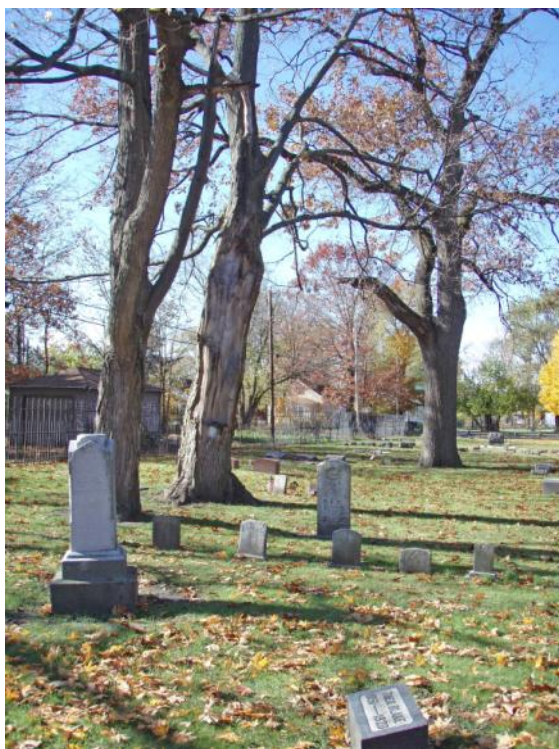
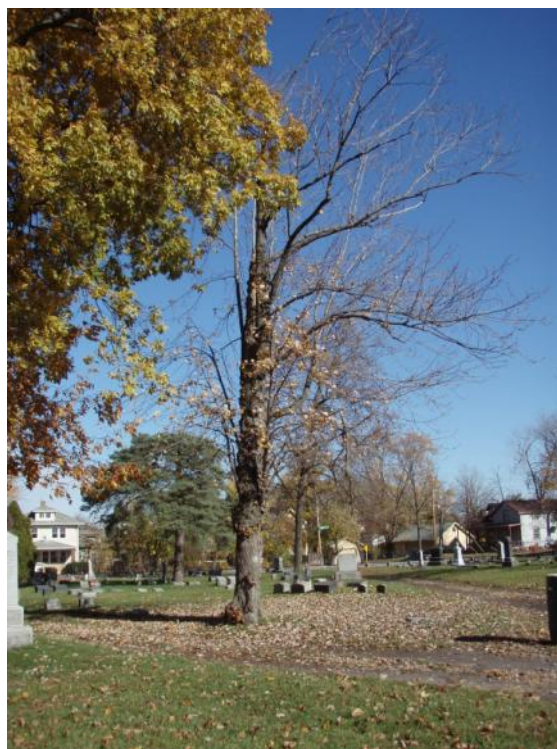
Figure 24. Examples of diseased or damaged trees. Note also damaged branches and crossed branches that require pruning.

In pruning, branches should always be cut just beyond the branch collar (an extension of the main stem) and not flush with the trunk. Large branches should be removed with three cuts to prevent tearing of the bark which can weaken the branch and lead to disease. All pruning within the cemetery should be performed by an ISA Certified Arborist, preferably one who is also an ISA Certified Tree Worker/Climber Specialist. The ISA Certified Tree Worker/Climber Specialist has knowledge in the major aspects involved in tree care

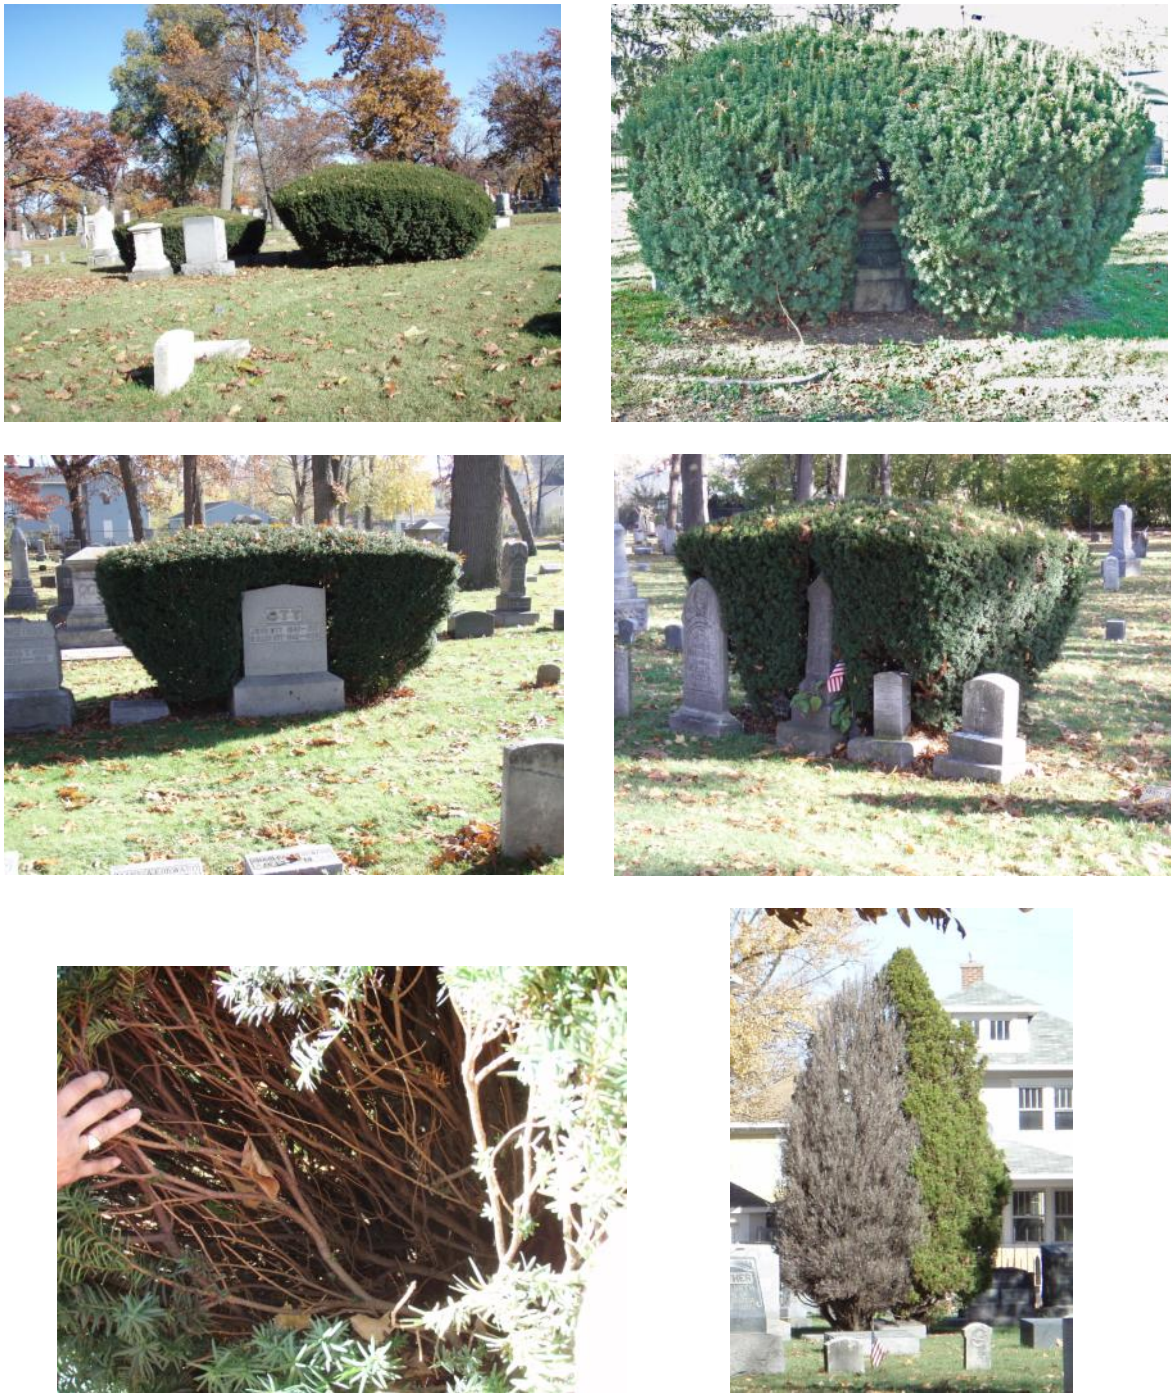
Figure 26. Examples of pruning problems at City Cemetery. The top and middle rows show shearing and the creation of inappropriate shapes. Note also how the shrubs have been pruned around stones. The lower left photo shows the deadwood in one shrub that has been sheared, rather than pruned. The lower right photo shows a dead shrub that should be removed.

Renewal pruning means cutting the plants back to within 6 to 12 inches of ground level. In this instance, timing is more important than technique. The best time to prune severely is before spring growth begins. Pruning in late fall or midwinter may encourage new growth that can be injured by cold. Renewal pruning results in abundant new growth by midsummer. Once the new shoots are 6 to 12 inches long, the

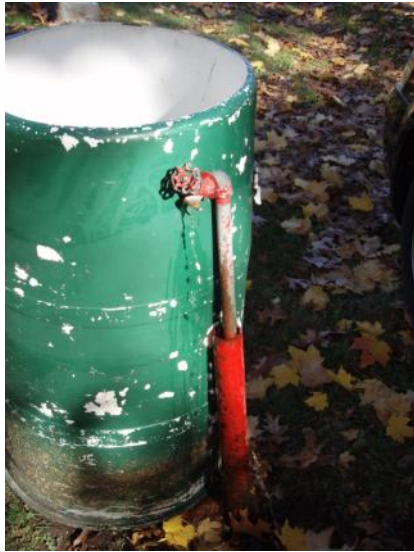
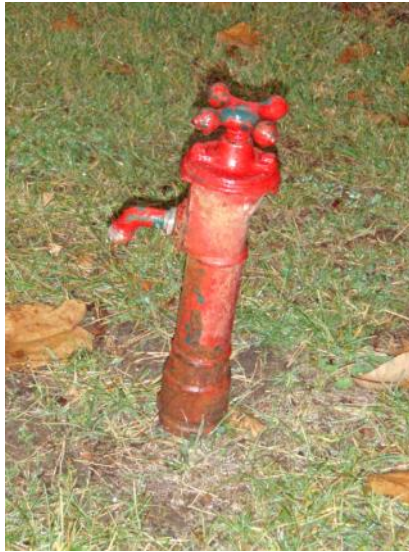
Figure 29. Examples of water bibs in the cemetery. On the left is a modern bib that is leaking and requires repair. On the right is a historic (and probably frost proof) model.

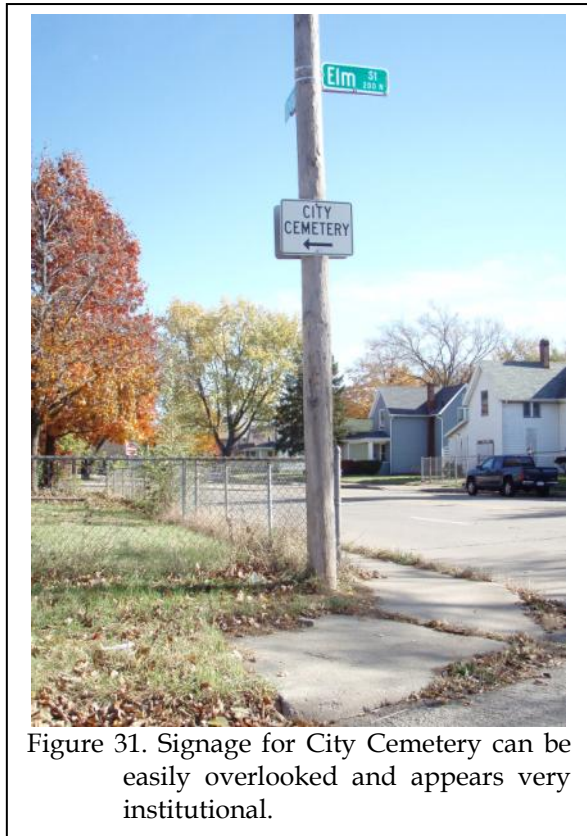
Figure 31. Signage for City Cemetery can be easily overlooked and appears very institutional.

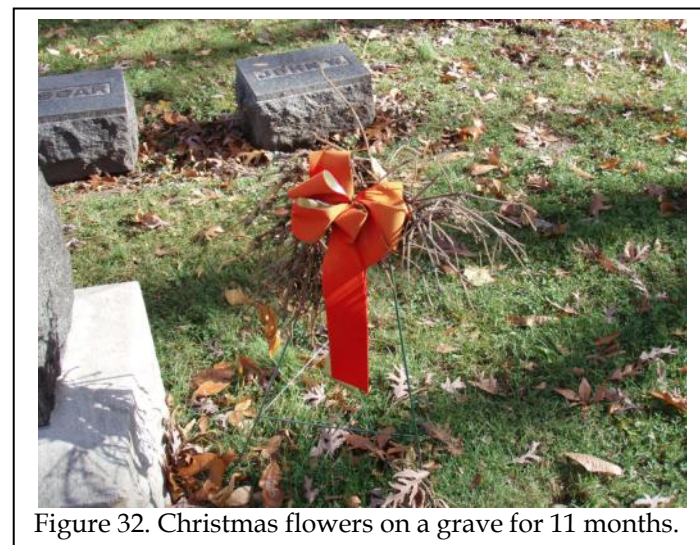
Figure 32. Christmas flowers on a grave for 11 months.

Finally, we recommend that the town adopt a flower policy that will minimize maintenance problems.

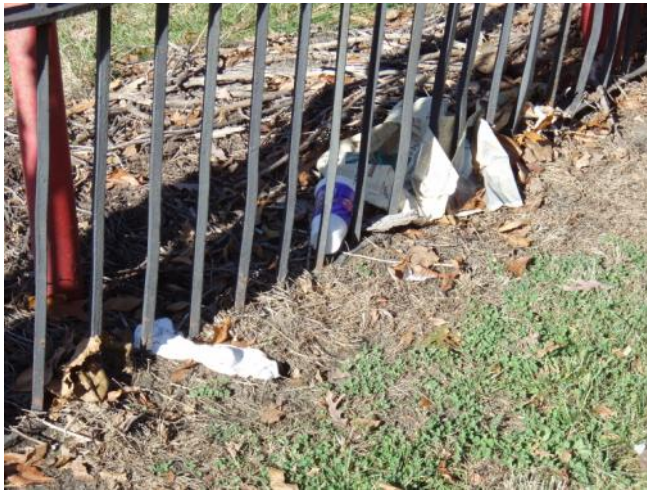
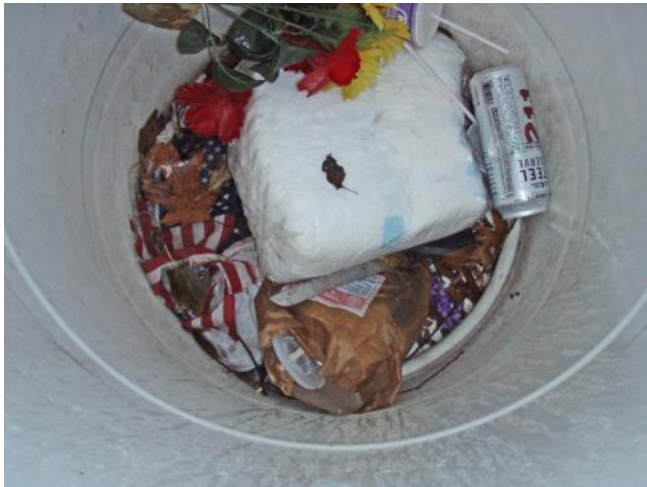
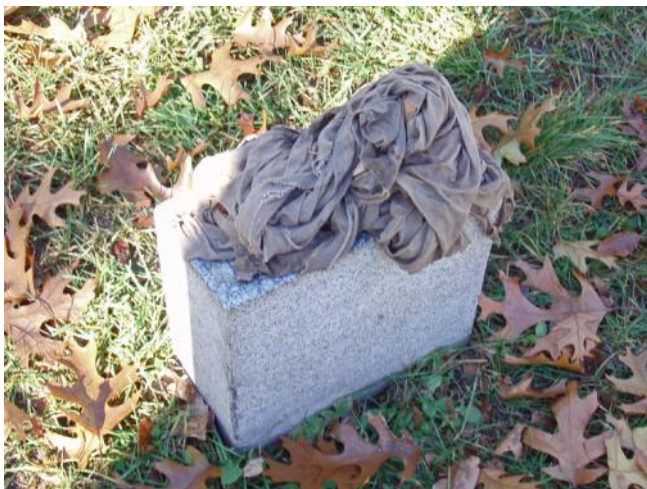
Figure 33. Examples of trash in the cemetery.

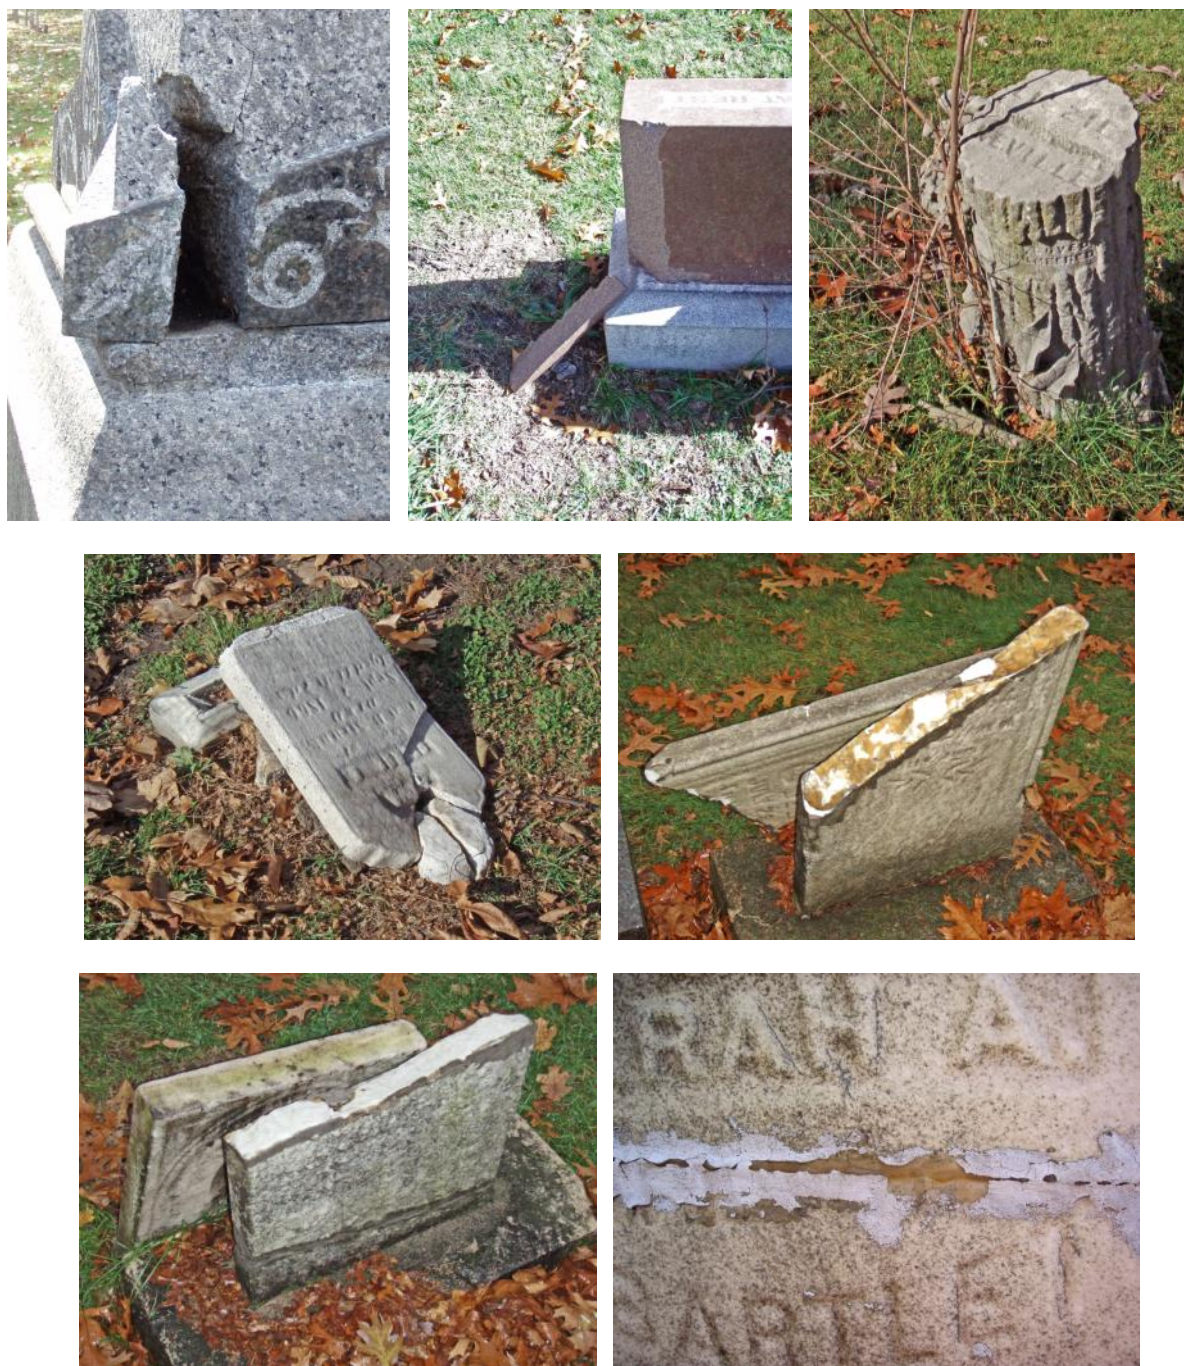
Sometimes pins are not used in a misguided or misinformed effort to save time and money. Instead the pieces are simply joined using a continuous bead of epoxy or some other adhesive. Experience indicates that for a long-lasting repair, particularly in structural applications, use of pins is necessary. Moreover, most adhesives are far stronger than the stone itself, meaning that failure of the repair is likely to cause additional damage to the stone.

Figure 34. Examples of broken and improperly repaired stones. Top left and middle photos show tree damaged granite markers. Top right shows a sandstone marker with a fragment broken off and lying on the ground. Middle left shows a marble tab in socket stone that has fallen and shattered. Middle right shows one of the many failed “simple epoxy” repairs in the cemetery; note the yellowing epoxy smeared on the stone face. Bottom left shows another failed repair. Bottom right shows where smeared epoxy is being covered by white paint.

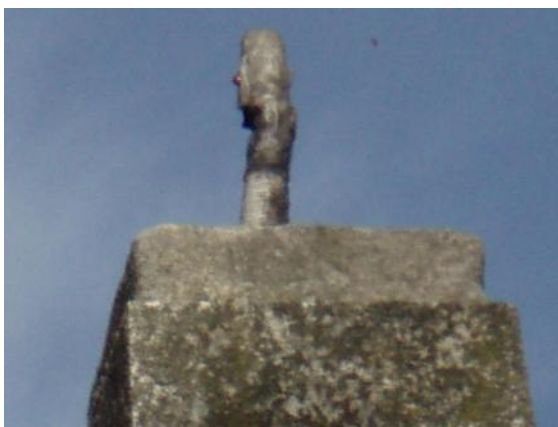
Several stones were observed with ferrous pins and these should be given a high treatment priority since, left untreated, the corrosion will cause significant spalling, cracking, and breakage of the stones. In these cases it will be necessary to use diamond core drills to remove the ferrous pins. They will then

Figure 35. Example of ferrous pin in a pedestal tomb. The associated urn is today missing, but the pin must be removed.

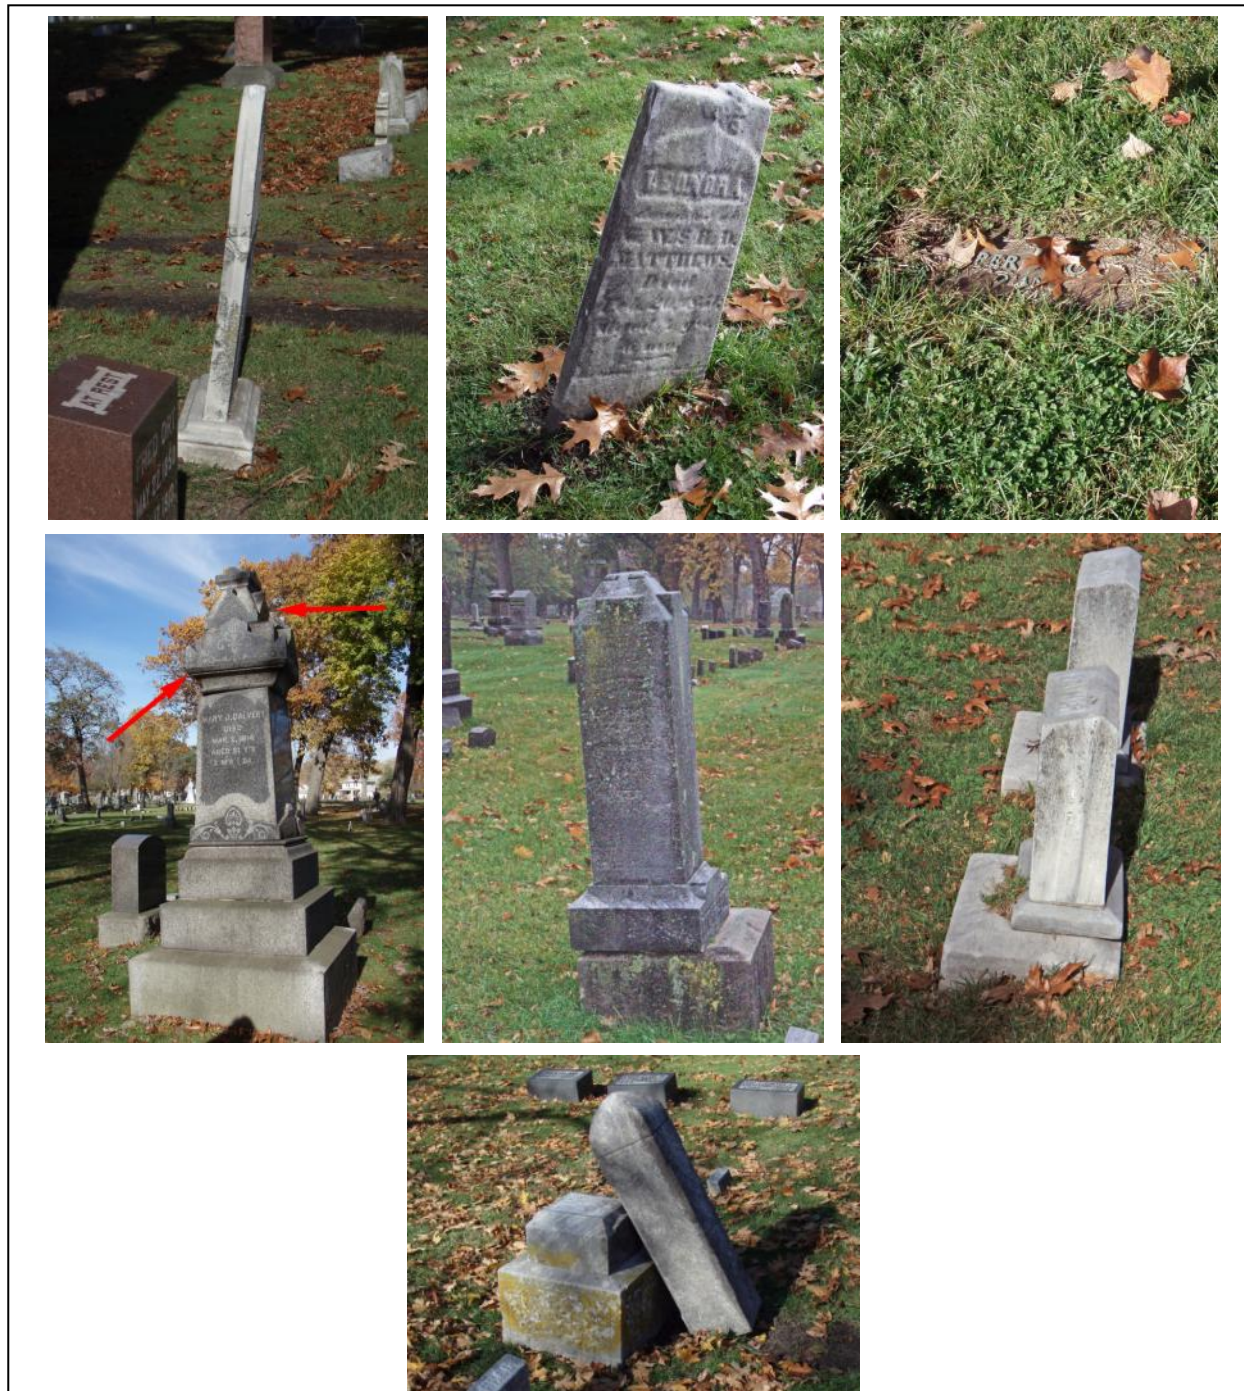
Figure 36. Examples of stones that require resetting. The top row illustrates simple resets that could be done by staff or volunteers with little training. Middle row left and middle illustrate two stones that could be a hazard to the public and require immediate conservation intervention. Middle row right shows a small stone that can be reset by volunteers. Bottom row illustrates the eventual result without treatment

Monuments should never be reset using concrete, but rather should be set in pea gravel.
